TECHNICAL NOTE

D-535

DAMAGE INCURRED ON A TILT-WING MULTIPROPELLER
VTOL/STOL AIRCRAFT OPERATING OVER A
LEVEL, GRAVEL-COVERED SURFACE

December 1960

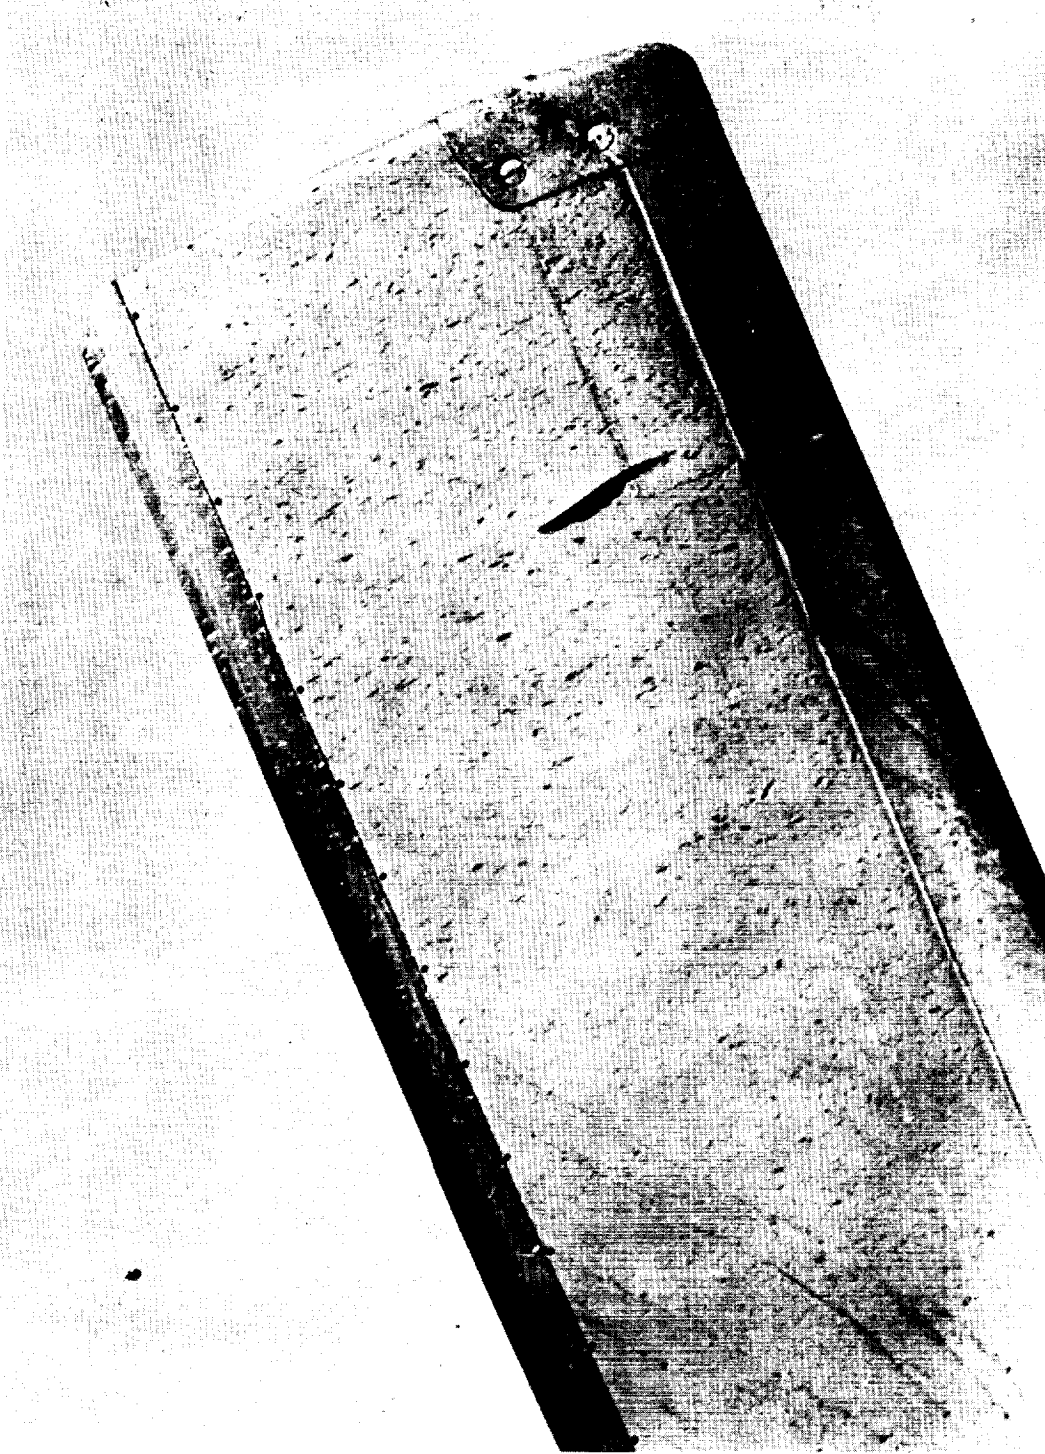
All rotating blades of the aircraft sustained some damage. The main rotor blades were at some angle of attack (approximately 6°) and the undersides of the blades showed the greater percentage of the damage. Figure 6 shows typical damage to the blades. This damage includes complete punctures of one side of the 0.070-inch-thick mahogany plywood skin on two blades, deep marring on all six blades, and peeling of the 0.008-inch-thick trailing-edge stiffener on one of the blades.

Figure 6.- Typical damage to main rotor blades. L-59-8139

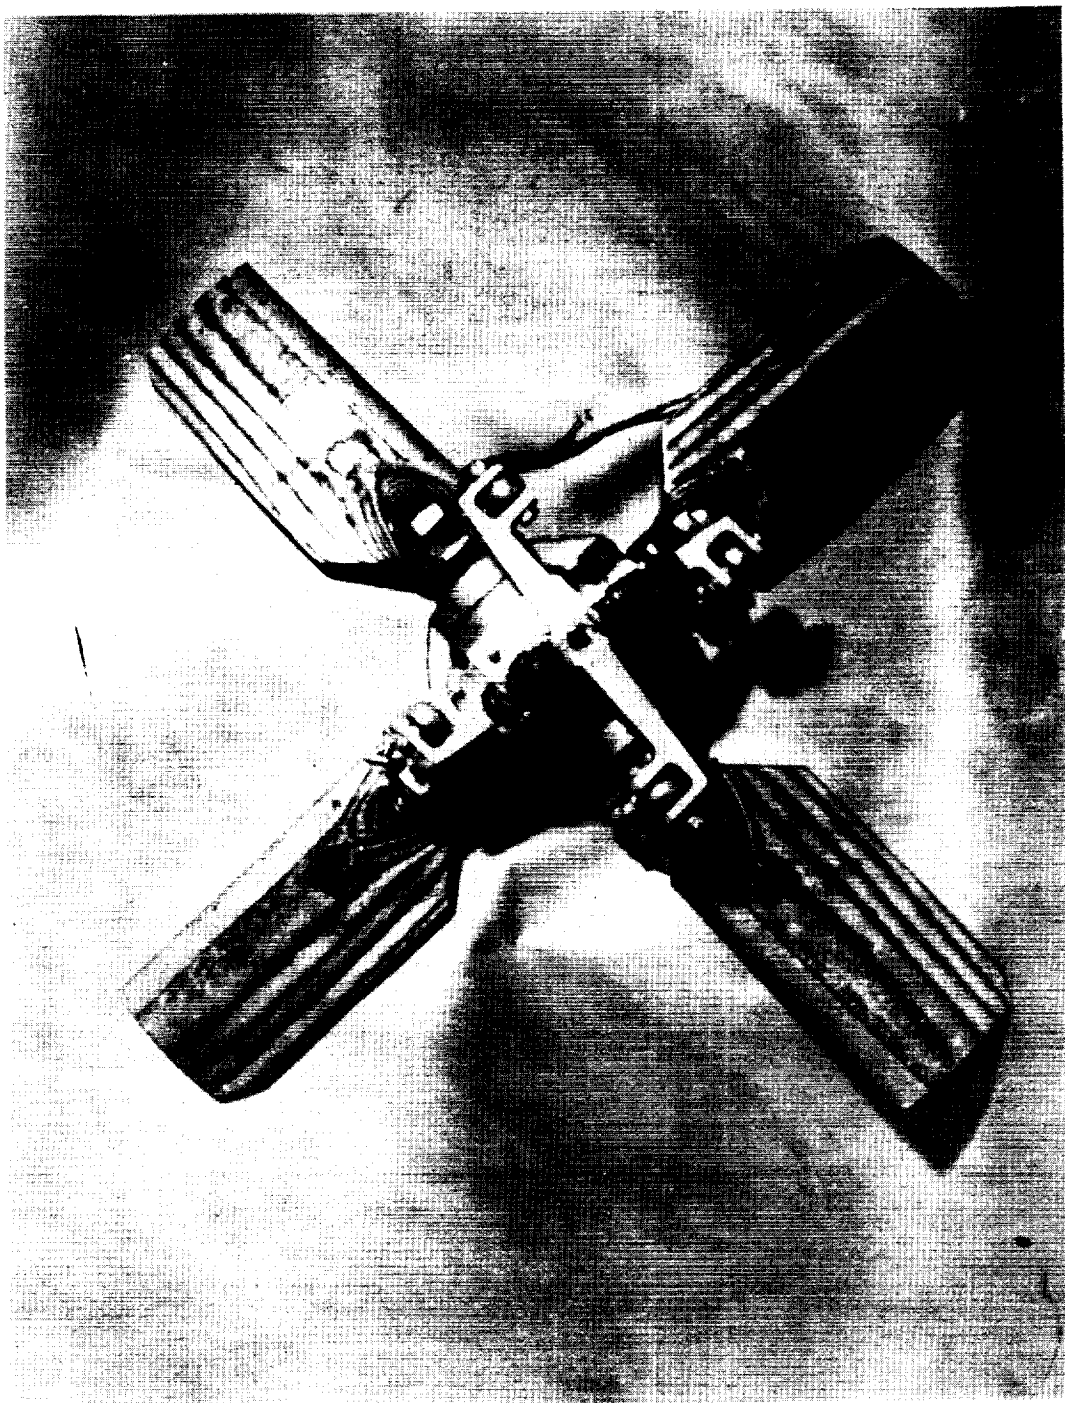
Serious gouging by flying stones marred the upper surfaces of the pitch fan (fig. 7) which was providing a downward thrust, and the right-hand surfaces of the yaw fan (fig. 8) which was providing thrust in the left-hand direction. The opposite surfaces showed relatively few scars except on the metal leading edge.

Figure 7.- Damage to pitch fan.

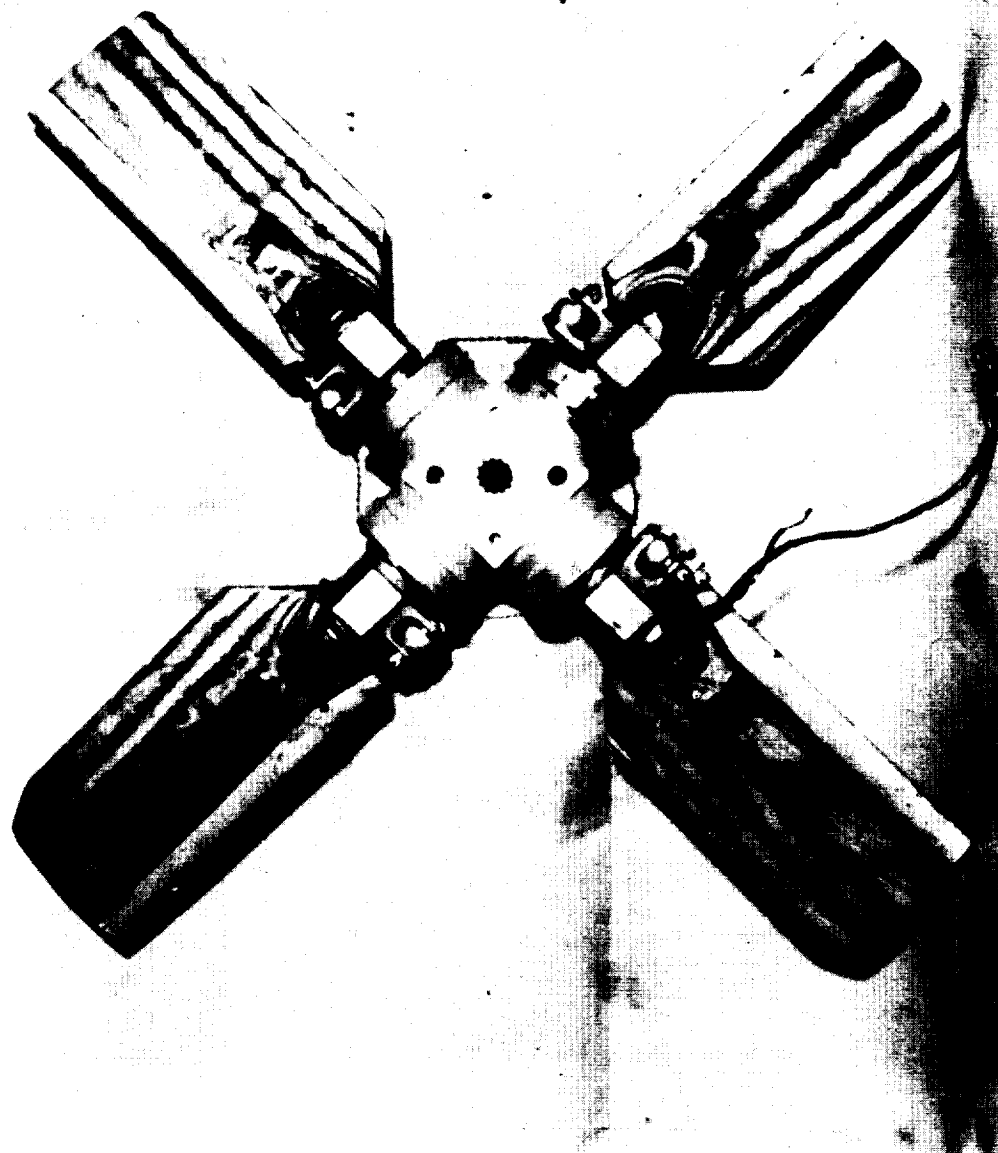
Figure 8.- Damage to yaw fan. L-60-4298

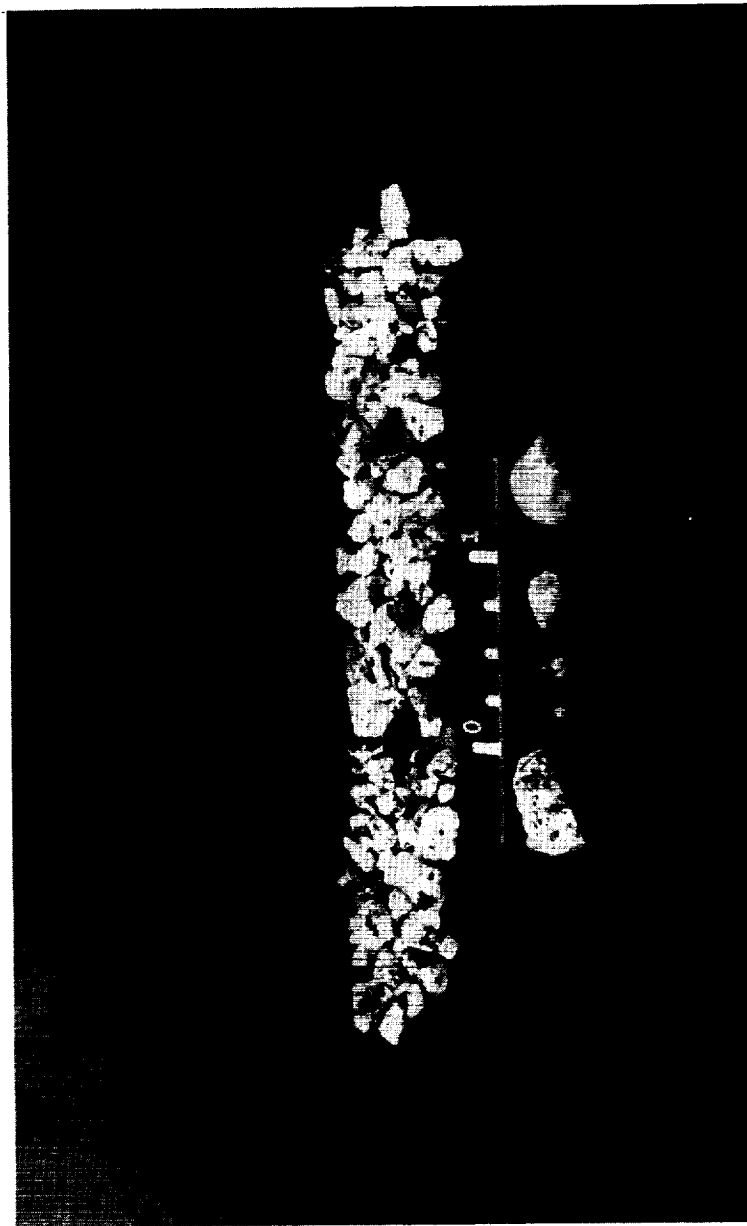
Little damage was incurred by the aircraft itself, but the upwash through the uncovered fuselage structure deposited a great deal of dirt and small stones throughout the open fuselage and cockpit and necessitated a thorough cleaning. Examples of the particles found on and inside the aircraft are shown in figure 9. No damage could be found to external and uncovered bearings. The pilot indicated that he experienced no abnormal handling difficulties during the return flight after the damage had occurred.

Figure 9.- Examples of stones found in fuselage. L-59-8146
